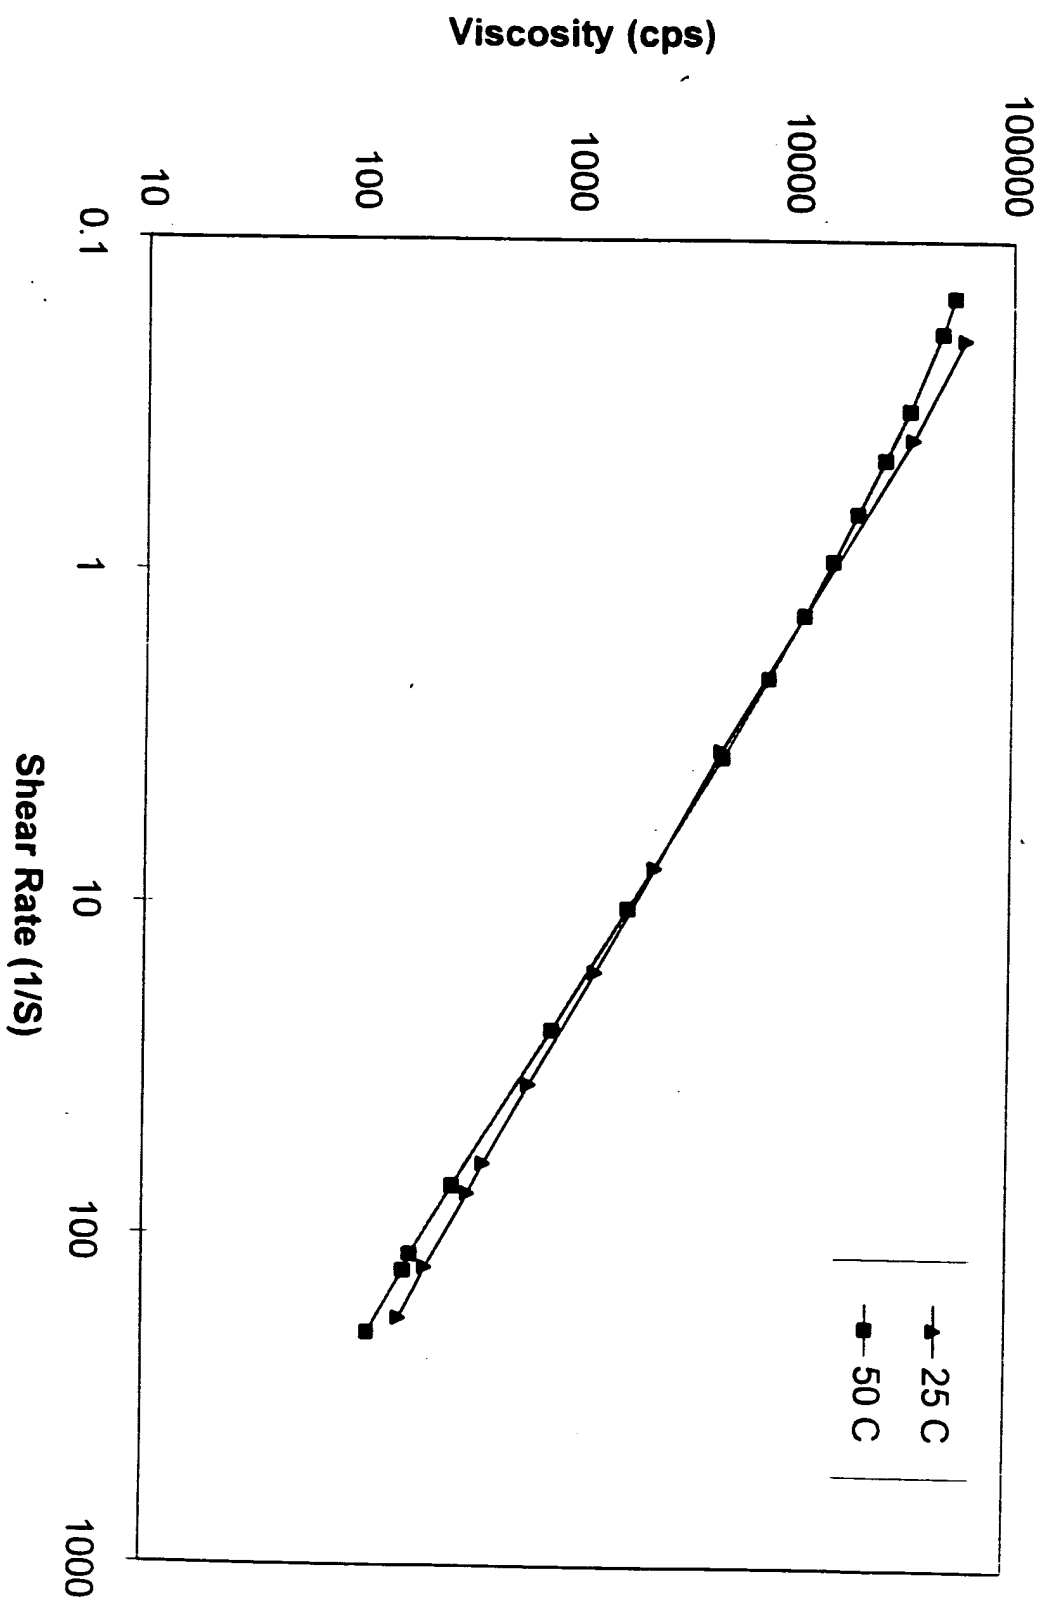
**Figure 1.** 5% disodium tallowiminodipropionate with 2.25% phthalic acid at 25 and 50 degree C

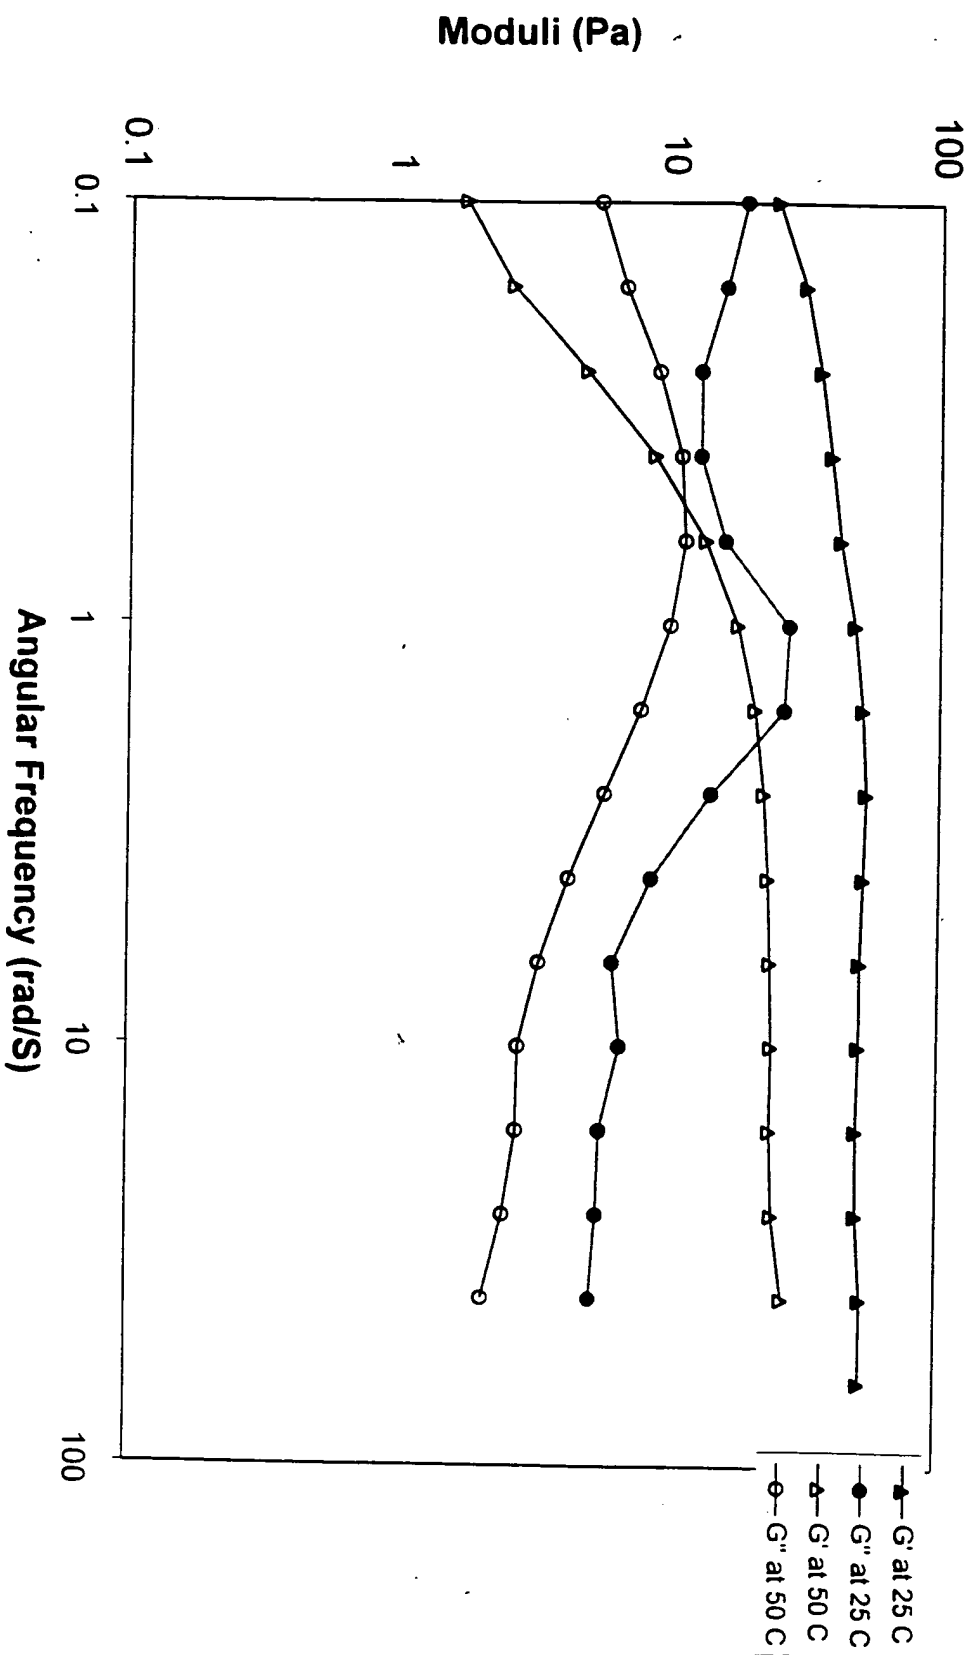
**Figure 2:** Dynamic shear moduli measurements for samples with 5% disodium tallowiminodipropionate and 2.25% phthalic acid at 25 and 50 degree C

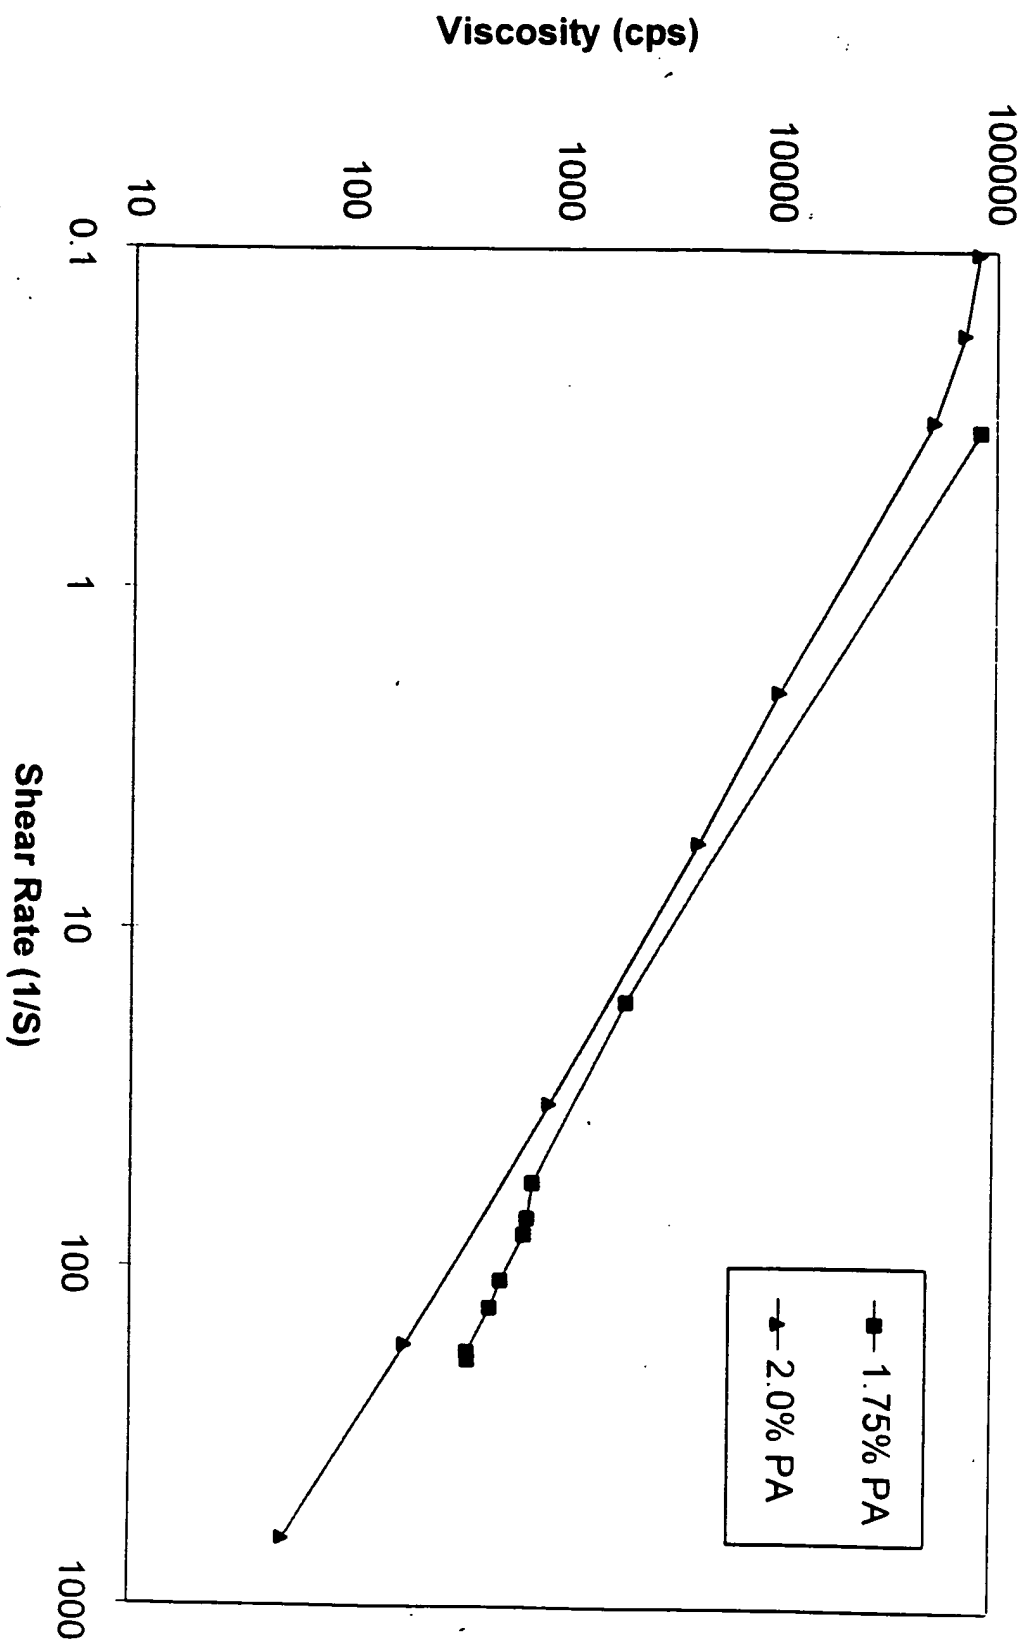
**Figure 3:** 5% disodium tallowiminodipropionate, 4% NH<sub>4</sub>Cl with different amount of phthalic acid (PA) at 25 C

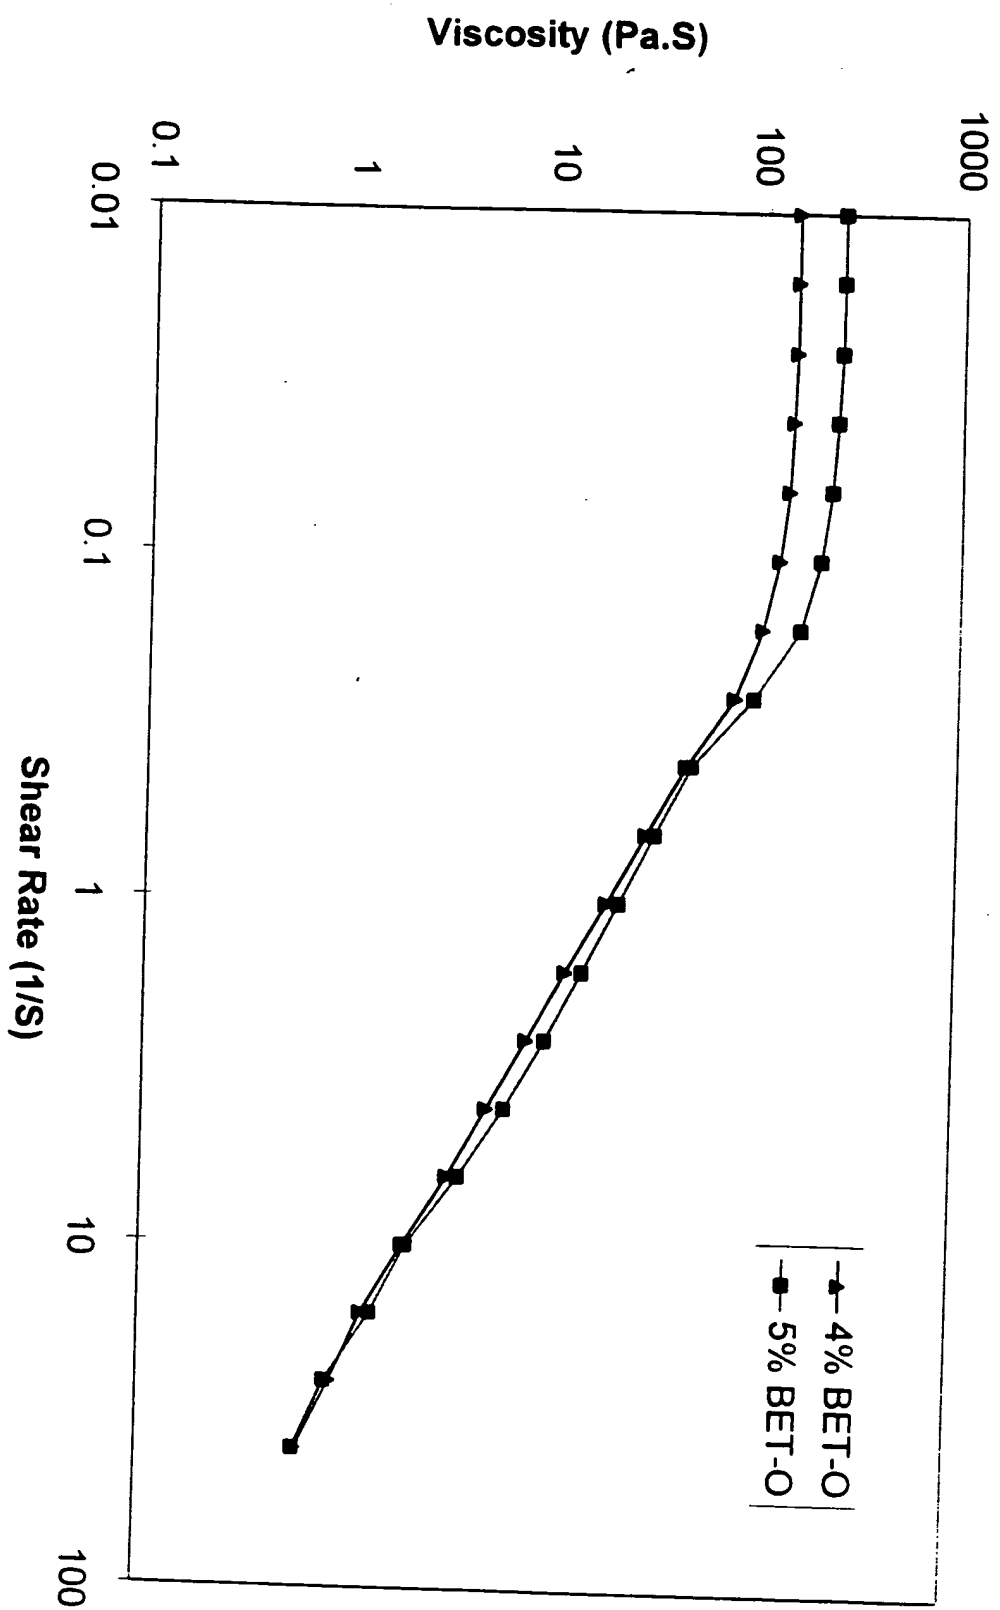
**Figure 4. Steady shear viscosity of different amount of oleamidopropyl betaine (BET-O) in presence of 3% KCl and 0.5% Phthalic Acid at 25 C**

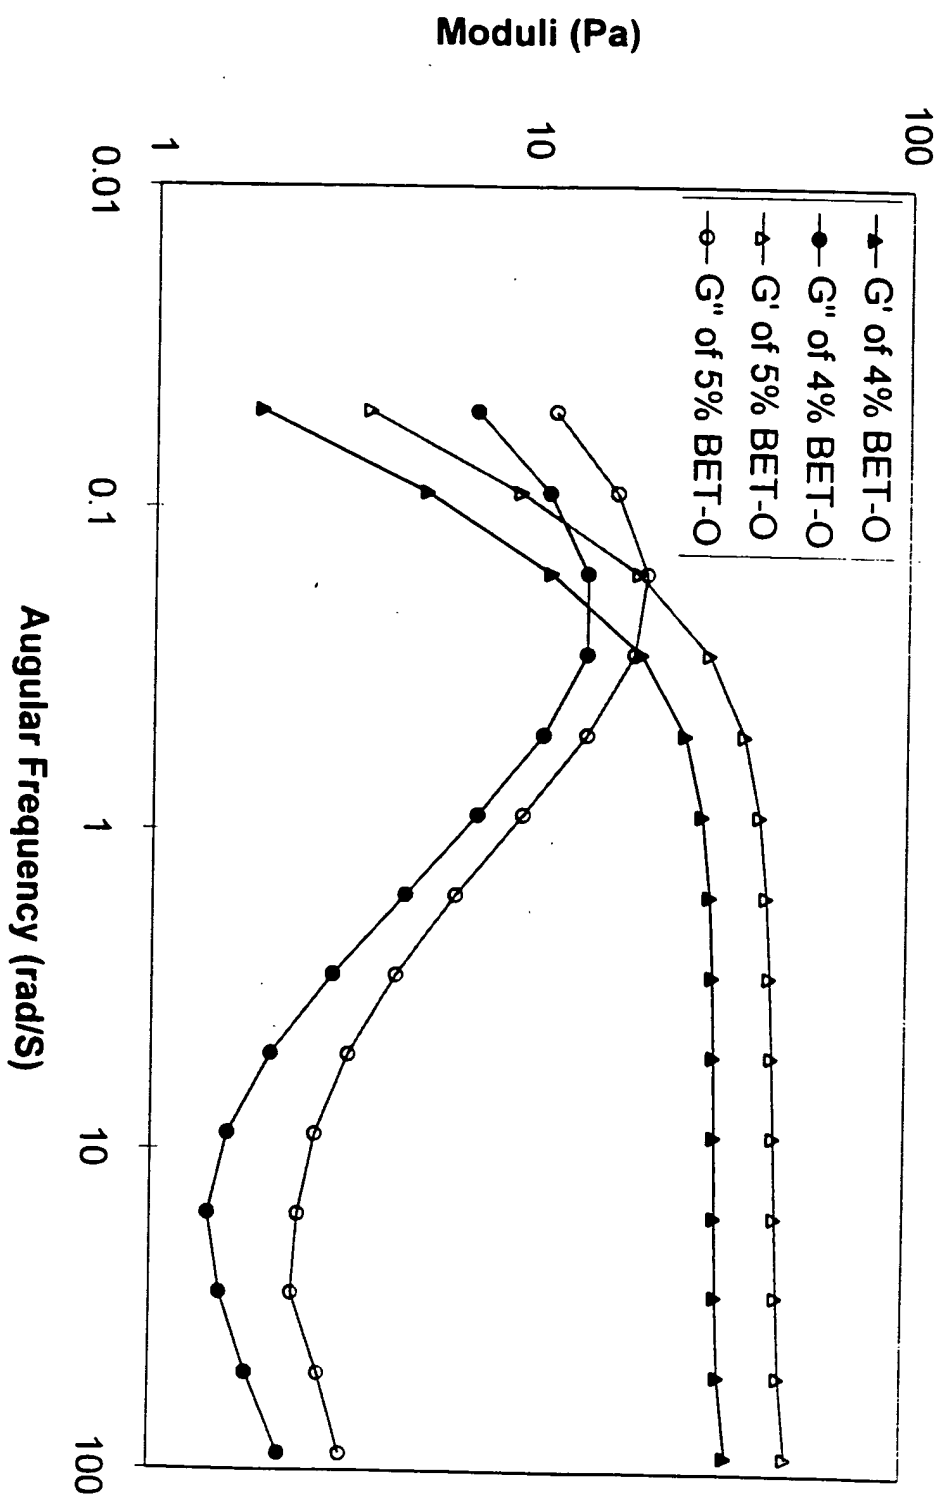
Figure 5. Dynamic shear moduli of different amount of oleamidopropyl betaine (BET-O) in presence of 3% KCl and 0.5% phthalic acid at 25 C.
